Operating Experience Weekly Summary 97-32

August 1 through August 7, 1997

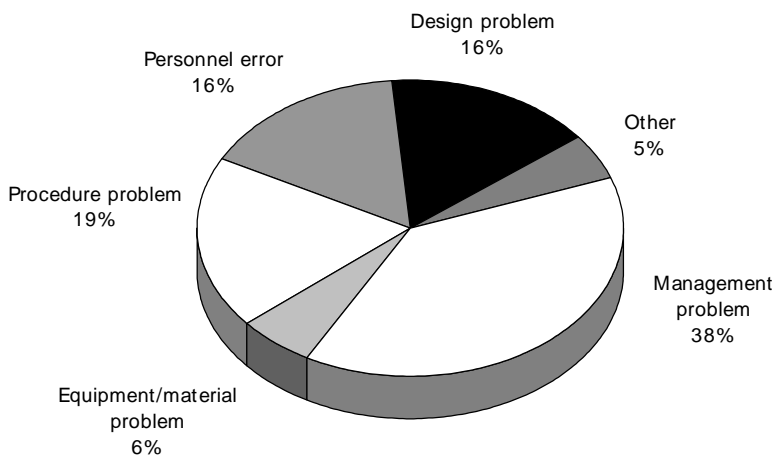
Figure 2-1. Distribution DOE-wide of Root Causes for Incompatible Chemicals and Pressurized Drum Events¹

Operating Experience Analysis and Feedback (OEAF) engineers screened the ORPS database for events involving incompatible chemical mixing and pressurization of drums and found 123 occurrences DOE-wide since 1992. Figure 2-1 shows the distribution of root causes reported by facility managers for these events. Thirty-eight percent of the root causes were management problems, and 41 percent of these problems were attributed to inadequate administrative control. This is an indicator that facility personnel across the DOE complex are not incorporating lessons learned from past events into procedures for handling hazardous chemicals.
